Yanmar 2QM20 Hours 132.8 (3600 USD)

Yanmar 2QM20 Hours 132.8 Year: 1980 Price: 3600\$ OBO

Make/Model: Yanmar 2QM20H (naturally aspirated)

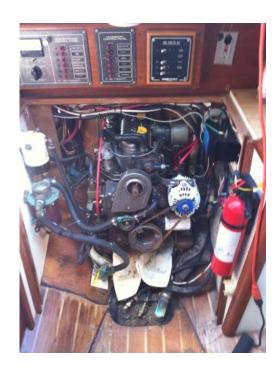
Engine runs great. I'm selling it because I'm installing an electric motor instead of diesel.

Horsepower: 20 Continuous @ 2600 rpm

The engine compartment was found in fairly good condition, though is very tightly filled. The engine and it?s accessories were found in fairly good condition.

The engine cold-started easily on demand, and ran for approximately 1 1/2 hours, while the vessel was underway motoring to/from the haul-out facility; and during the underway motor trial run. No excessive vibration was noted. The transmission shifted smoothly and quietly into forward and reverse, and appeared to have normal power in both directions. No unusual fluid leakage was found at the engine, transmission or related accessories - except for a slight fuel leak at the 12 volt fuel lift pump. The engine?s helm controls were functional, and the engine responded to the controls, as expected, with no unusual delays. Visibility from the helm station is good.
